**SUSQUEHANNA RIVER BASIN  
LEWIS LAKE DAM**

NDI NO. PA-00061  
DER NO. 58-7

**PHASE I INSPECTION REPORT  
NATIONAL DAM INSPECTION PROGRAM**

**AUGUST 1980**

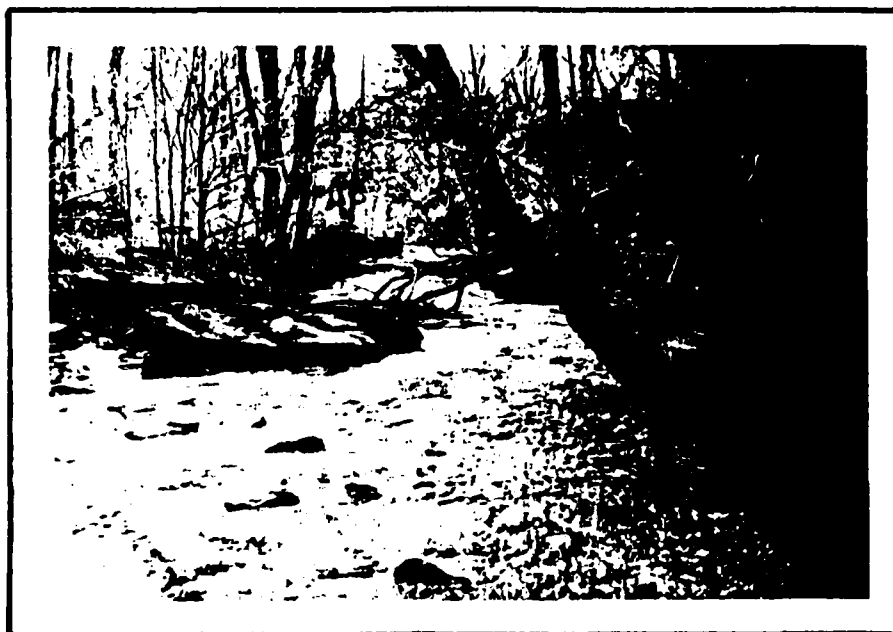
DOWNSTREAM CHANNEL OF SPILLWAY - NO. 6
